# HOME INSPECTION REPORT

16 Placid Way  
Stafford, VA 22554

Prepared for: Janet MacClient

REPORT NUMBER: 022609-M

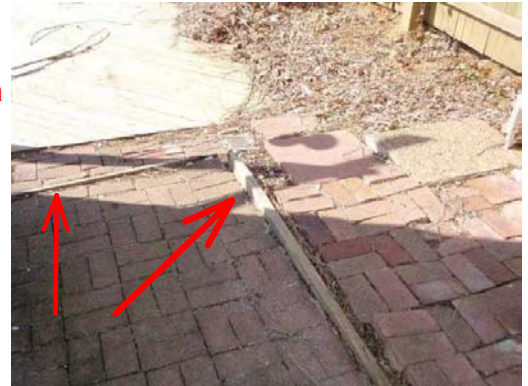
- 1.      Driveway: Concrete:: I observed evidence of spalling, minor surface deterioration, and prior repairs
- 2.      Walks: Concrete, Wood, Pavers:: **Wood edging of paver walk and steps sticking up above the uneven paver surface creating a trip hazard. I recommend a qualified person or licensed contractor repair the walk surface to eliminate the trip hazards.**

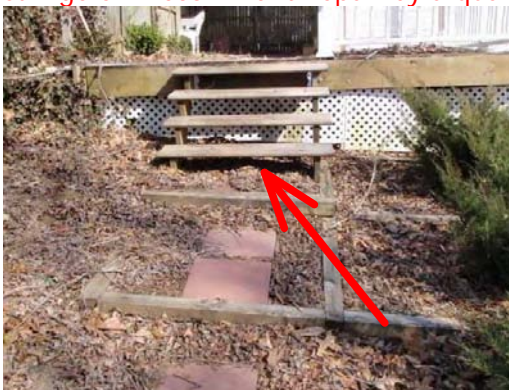
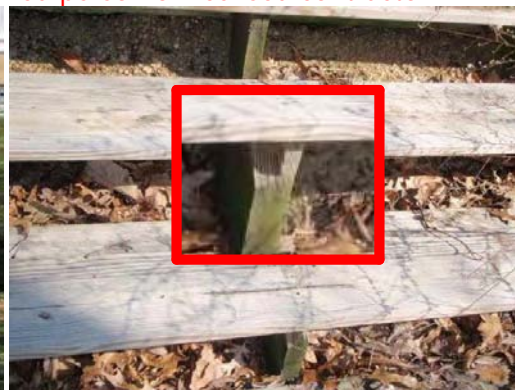
- 3.      Steps: Wood:: **Rear deck steps: I observed uneven step risers and deteriorated stair stringers. I recommend repair by a qualified person or licensed contractor**

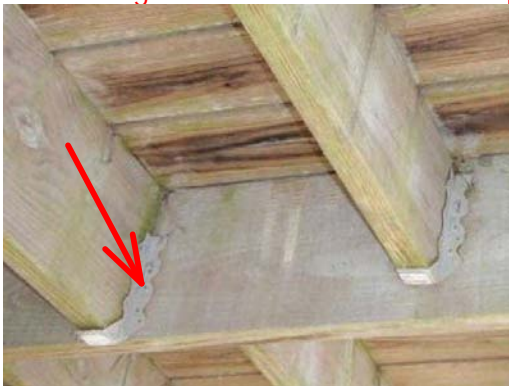
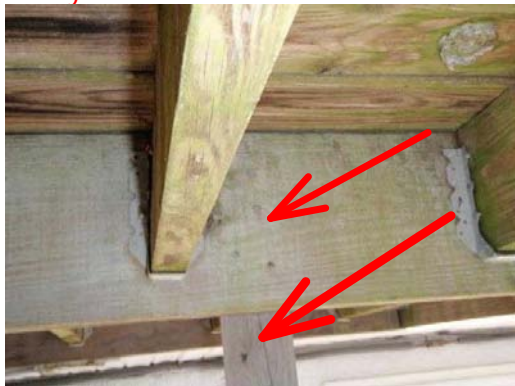
- 5.      Deck: Pressure treated wood 1x6 decking:: **Inadequate nailing of joist hangers. Every round hole requires a proper nail; Improper connection of center beam to support posts. Not Bolted and no support under the beam. Not bolted to the house; Ledger flashing not visible. Weathering of surface. I recommend repair by a licensed contractor.**

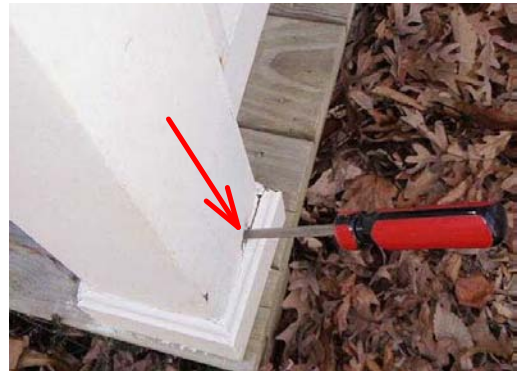
- 6.      Porch: Treated Wood:: Base of right support post shows evidence of damage by WDO. I recommend repair by a qualified person or licensed contractor.

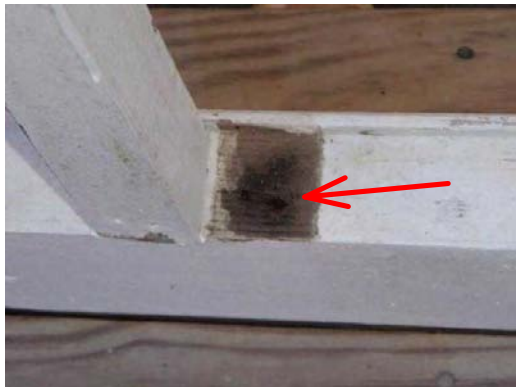
- 8.      Railings: Painted wood rails with painted wood balusters:: Front porch painted wood railing: Loose and WDO damaged balusters. I recommend repair by a qualified person or licensed contractor.

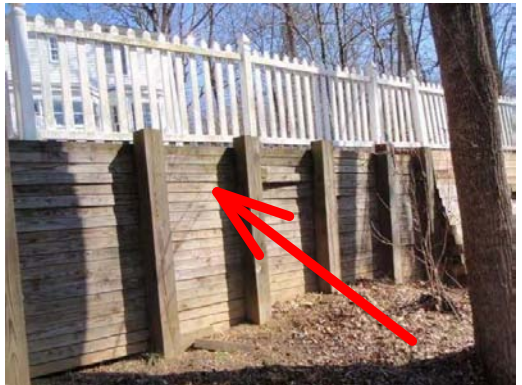
- 10.      Retaining Walls: Wood, Concrete:: A section of treated wood retaining wall below the pool shows evidence of bowing. I recommend having a structural engineer evaluate the wall and prescribe corrective actions if required, in the near future. Small vertical cracks were observed in the concrete retaining walls around the pool deck. This type of crack is generally considered a normal occurrence in residential concrete work as long as they do not have differential displacement, do not grow to more than approximately 1/8" inch in width, and do not have water seepage. You may just seal the cracks or consider consulting with a structural engineer for a thorough professional evaluation of the wall cracks.

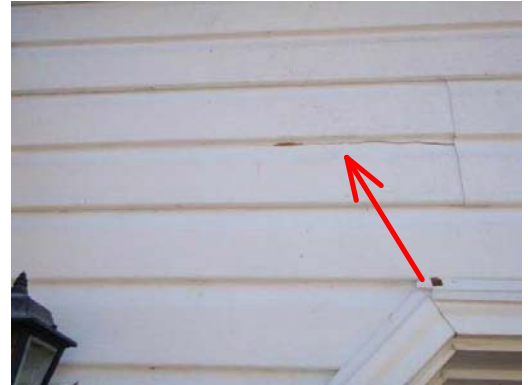
- 1.      Type: Vinyl siding
- 2.      Condition Requires maintenance, Requires repair::  
Caulking required at windows, doors, and/or trim. Caulk provides a moisture, wind, and insect barrier that should be maintained on at least annually. Deteriorated caulking can allow water to enter the structure causing damage to the structure and interior. Insects may use the opening as a convenient road into the house. Observed crack or other damage to siding over the garage door allowing water penetration and possible water related damage to the substructure and interior. Requires repair, or replacement.

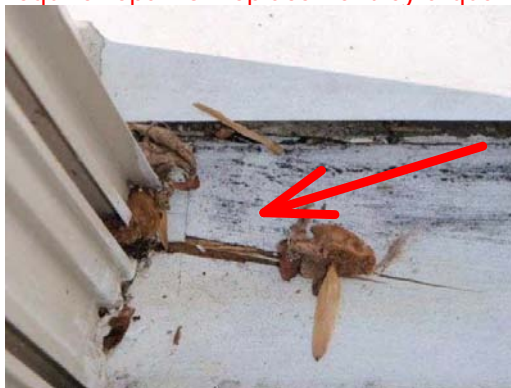
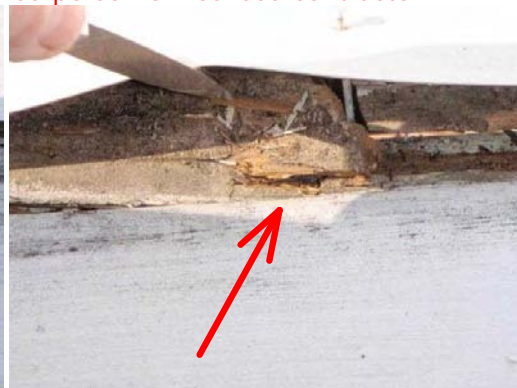
- 8.      Patio Door: Vinyl sliding
- 9.      Windows: Wood:: Deteriorated paint in window sills requires maintenance or repair. I observed sills damaged by Wood Destroying Organism, most likely fungal rot. These sills require repair or replacement by a qualified person or licensed contractor

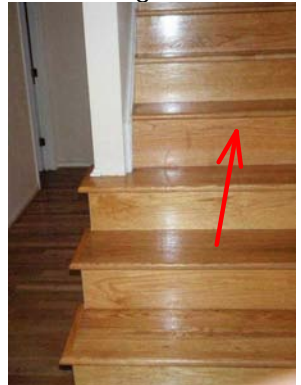
- 9.      Stairs: Wood stairs with wood handrails:: **Main stairway to second floor: One tread riser is about 1" higher than the average for the stairs presenting a trip and fall hazard. The stairs require repair by a qualified person or licensed contractor.**

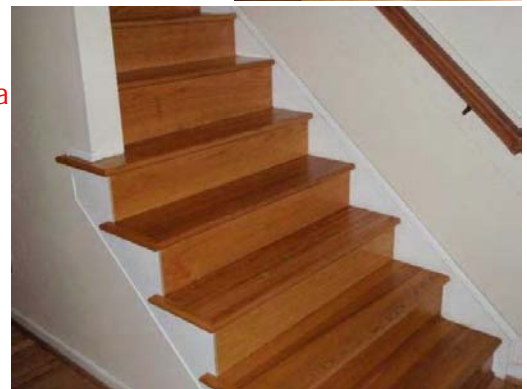
- 10.      Railings: Missing railing section:: **The handrail for the lower stair section has been removed leaving a five step section without fall protection. This is also a safety hazard that requires repair by a qualified person or licensed contractor.**

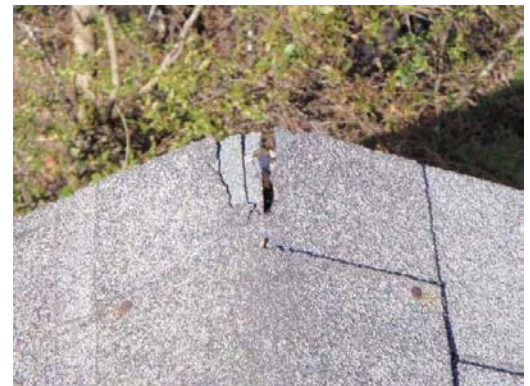
- 5.      Surface Condition: Normal aging and wear, moderate damage:: Ridge cap split at end of main roof exposing roof decking to weather an moisture. Damaged left corner of front porch roof is damaged allowing water to penetrate and damage the decking. At least temporary repairs are required as soon as possible to prevent leaks and damage or reduce existing leaks and additional damage.

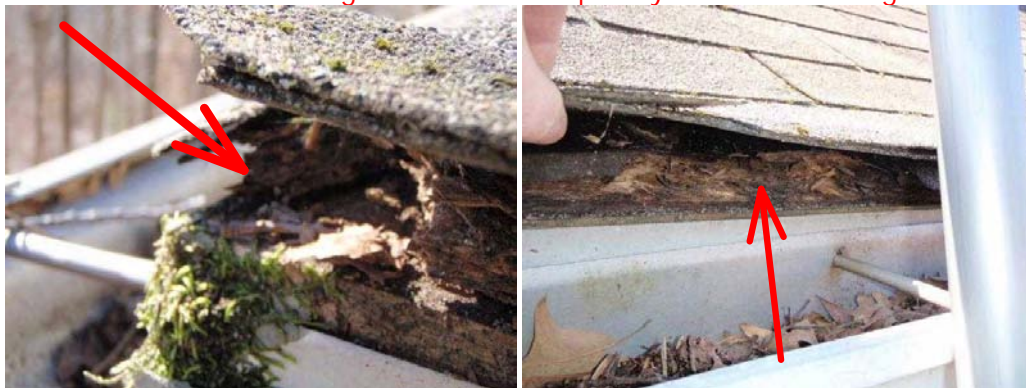
- 6.      Approximate Life: Less than 5 years:: There are too many variables to allow an accurate estimate of the remaining roof life. Therefore, in order to provide some assistance, a broad range is presented to give you a general idea of how soon the roof may need replacing.
- 7.      Decking/Nailing: OSB Decking, Galvanized roofing nails:: Water damage at eaves. Overflow from gutters has backed up into the OSB decking at the edge of the roof causing deterioration of the decking. I recommend repair by a licensed roofing contractor.

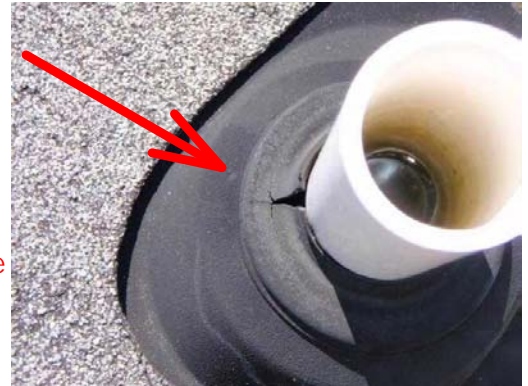
- 9.      Valleys: Cut-line shingle valleys
- 10.      Plumbing Vents: PVC:: Weather boots are deteriorated with cracks, tears, or splits. This condition will allow water into the property causing damage to the roof decking/structure, or to the interior ceilings, walls, and floors. I recommend repair/replacement of plumbing vent flashing and weather seals by a qualified person or licensed roofing contractor. See "Attic" for picture from inside around the vent pipe.

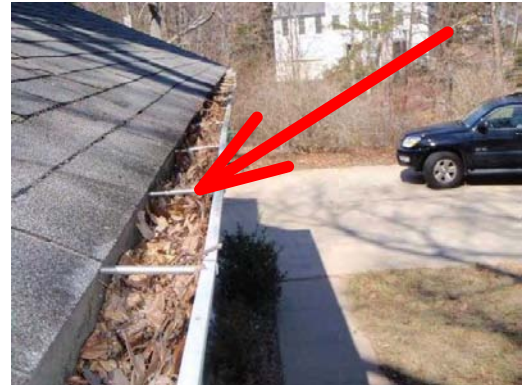
- 12.      Gutters: Aluminum:: Gutters loose, spikes or straps pulled out or missing. A condition that may severely reduce gutter efficiency and permit moisture entry into the structure or saturate the ground at the foundation. Gutters need cleaning. Clogged gutters can lead to overflow and water penetration into structure or saturate the ground at the foundation. Water can cause structural damage and provide the moisture necessary for mold growth and the existence of termite colonies. I recommend gutter cleaning as part of a regular maintenance program. Uncovered or unscreened gutters should be cleaned at least twice a year to prevent a buildup of debris. Part of the maintenance should also include tightening loose spikes or brackets and sealing any seam leaks.

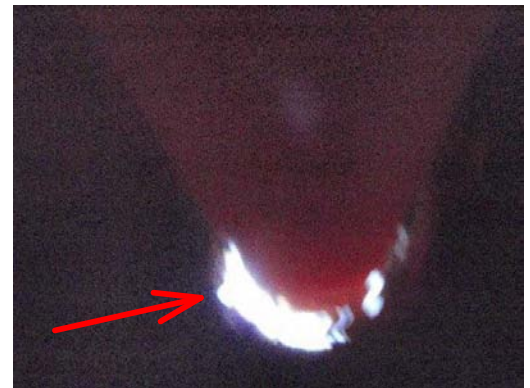
- 10.      Insulation: Fiberglass Batts (3.14R/in)
- 11.      Insulation Depth: 12", nominal depth
- 12.      Waste Vents PVC.: Observed light passing between the pipe and the weather boot. This situation will allow water penetration into the structure. See "Roof, Plumbing Vents" for repair statement

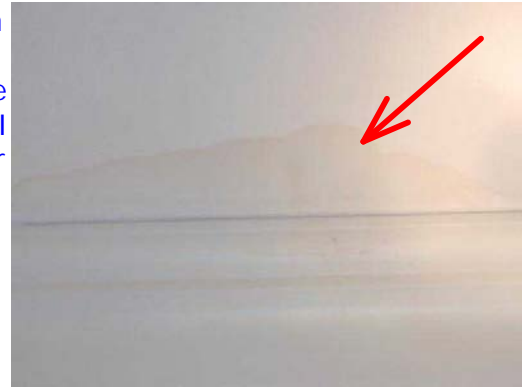
1.  Ceilings: Drywall and Paint:: I observed nail pops in the drywall around the house. Evidence of a prior water leak above the kitchen ceiling appears to have come from the bathroom above the stained ceiling. I recommend a qualified person or licensed contractor caulk the tub at the floor in the bathroom and applying a stain blocking primer over the stained area prior to painting

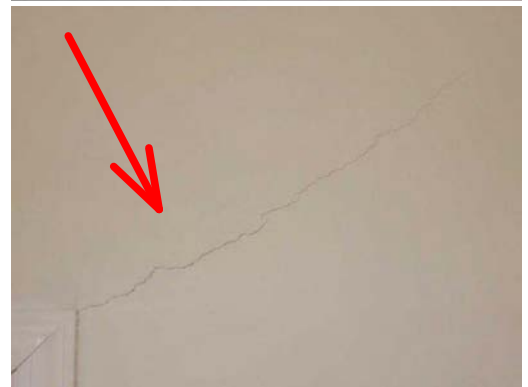
2.  Walls: Drywall and Paint:: I observed a diagonal crack in the wall at the corner of the door to the master bathroom. This crack may be due to normal settling but also may be due to inadequate support under the wall. I recommend repairing the crack. If the crack returns or grows, I recommend a structural engineer evaluate the crack and prescribe corrective action as required

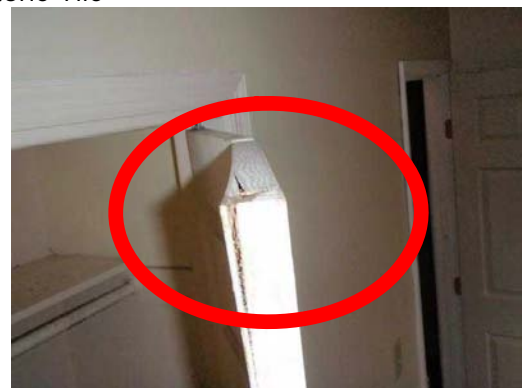
3.  Closets: Present in bedrooms and hallways  
 4.  Flooring: Carpet, Hardwood, Vinyl floor coverings, Stone Tile  
 5.  Interior Doors: Painted hollow-core molded composite:: Bifold closet door in bedroom requires adjustment and repair. A top track roller is missing and the door is damage where the roller is inserted in the door. The right side master bathroom door needs adjustment apparently due to the settling of the wall and door frame. I recommend repair by a qualified person.

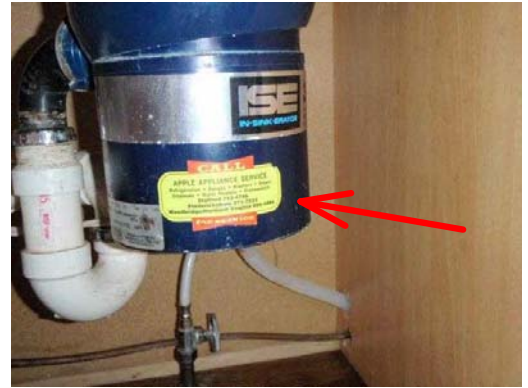
- 1.      Cooking Appliances: 4 burner range, Frigidaire, electric
- 2.      Ventilator: Range Top Down Draft:: Control dial indicates adjustable speed. Only one speed at the time of inspection
- 3.      Disposal: Not functional at the time of inspection, Motor locked, hums only:: **I recommend repair or replacement by a qualified person or licensed plumber contractor**

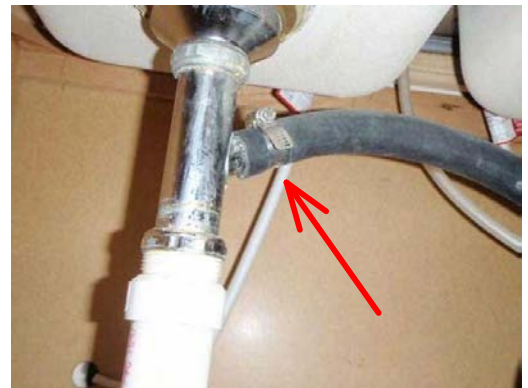
- 4.      Dishwasher: Whirlpool:: Dishwasher drain bypasses disposal and connects to second sink drain. This appears to be a DIY fix for non-functional disposal. You may wish to have the drain line connected back to the disposal when it is replaced.

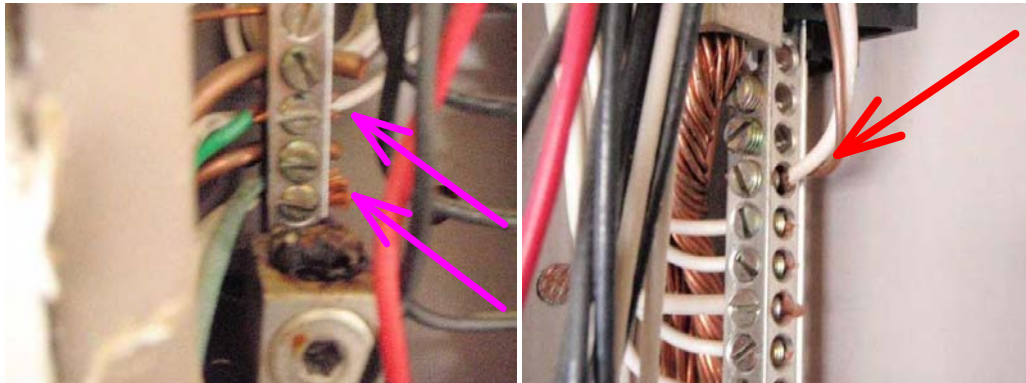
6.      Maximum Capacity: 200 Amps, Determined by main breaker
7.      Manufacturer: Cutler-Hammer
8.      Main Breaker Size: 200 Amps
9.      Breakers: Copper and Aluminum
10.      Fuses:
11.      Aluminum Wiring Aluminum solid-wire branch wiring was not present at the time of inspection
12.      120V Conductors Copper
13.      240V Conductors Special purpose localized aluminum circuits
14.      GFCI: GFCI dedicated circuits marked.
15.      Conductor Type Non-metallic sheathed cable
16.      Wiring Neutral (white) conductors and a ground (bare copper or green wire) together in one buss bar terminal. **Improper wiring technique, Neutral and grounds are combined into one tap, This is a recognized safety and fire hazard that requires correction by a qualified electrical contractor**

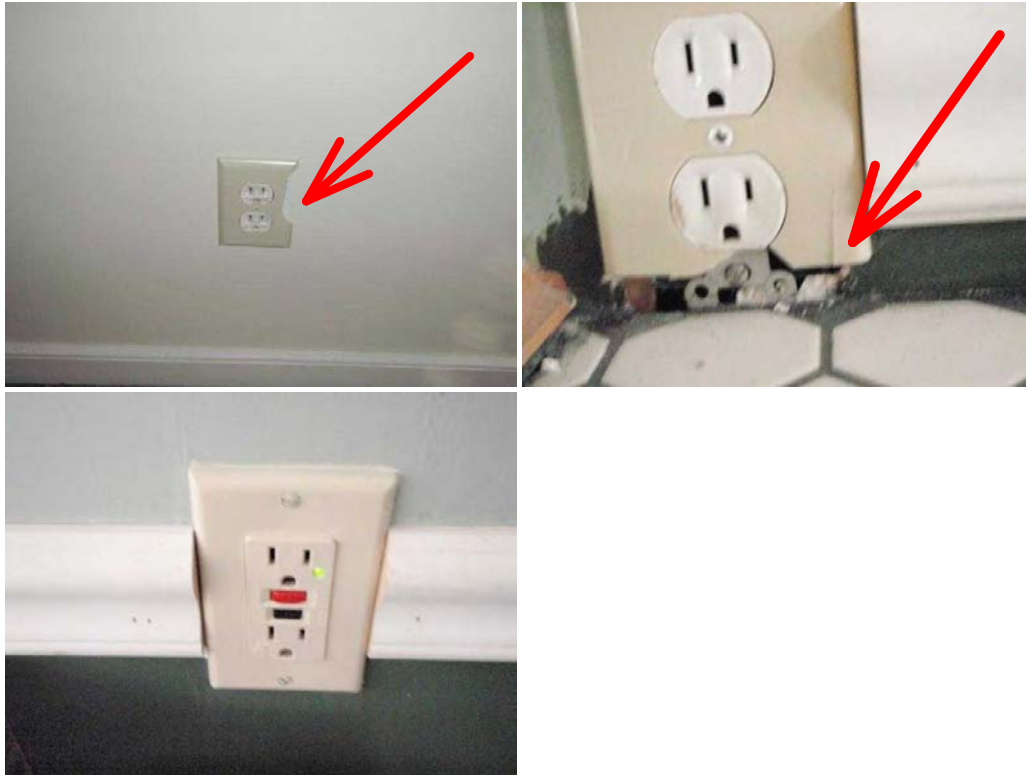
20.      Switches/Outlets: safety Issues noted:: Broken receptacle plate in bedroom and behind bar in basement presenting a safety hazard. Replace covers. GFCI receptacle behind basement bar does not trip on "test" or reset. Requires replacement by a qualified person or licensed electrical contractor.

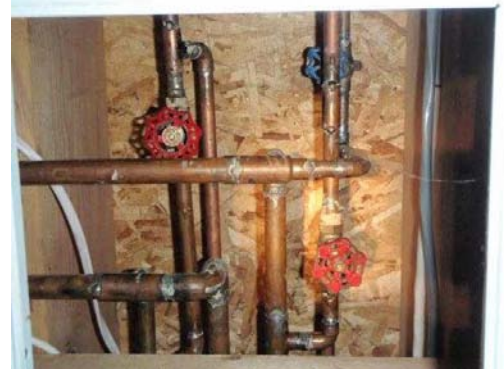
1.      Service Line: Copper:: Entry into structure not visible due to wall coverings
2.      Main Water Shutoff: Basement
3.      Water Lines: Copper
4.      Vent Pipes: PVC
5.      Basement Floor Drain: Surface drain
6.      Drain Pipes: PVC
7.      Service Caps: Not visible:: A service or clean-out plug for the waste lines was not observed during the inspection. Drain lines have limited visibility due to wall and ceiling coverings.
8.      Kitchen Sink: Stainless Steel, Double
9.      Bathroom Sink/Basin: One piece sink/counter tops
10.      Faucets/Traps: Faucet with hot/cold supply control, PVC P-trap & Drain
11.      Plumbing/Fixtures: Appear functional at time of inspection., No active leaks observed. Three unmarked valves in ceiling of basement half-bath. May be for outside faucets.

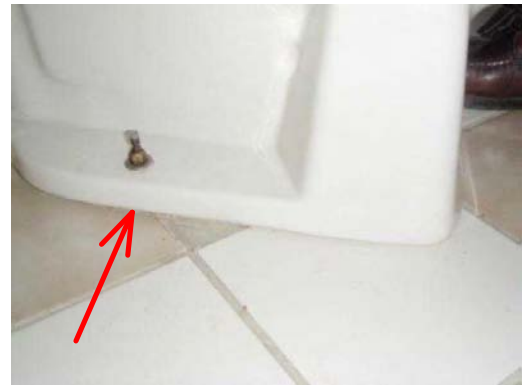
12.      Sump Pump:
13.      Ejector Pump:
14.      Tub/Surround: Porcelain tub, Ceramic tile surround
15.      Toilets: 1 1/2 Gallon Tank:: Toilet in first floor half-bath is slightly loose at floor mount. I recommend a qualified person or licensed plumbing contractor tighten the toilet and seal around the base of the toilet to prevent water from possible overflows leaking through the floor and into the ceiling in the basement.

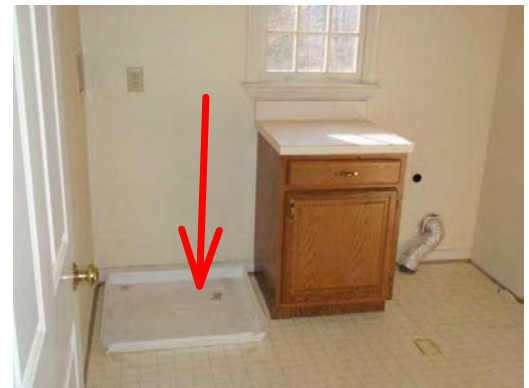
- 23.  Hose Bibs: In wall-mounted washer service box with washer drain
- 24.
- 25.  Electrical: 120 VAC/240 VAC
- 26.  Dryer Vent: Vents through wall to outside
- 27.  Floor Drain: Drain pipe attached to washer drip pan
- 28.  Drip Pan: Plastic Pan:: Broken pan will not hold water. I recommend replacing the pan

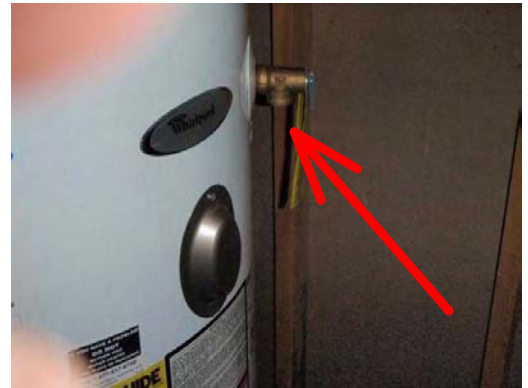
41.      TPRV Drain Tube: Not installed. This is a safety hazard and requires repair or replacement by a qualified person or licensed plumbing contractor.

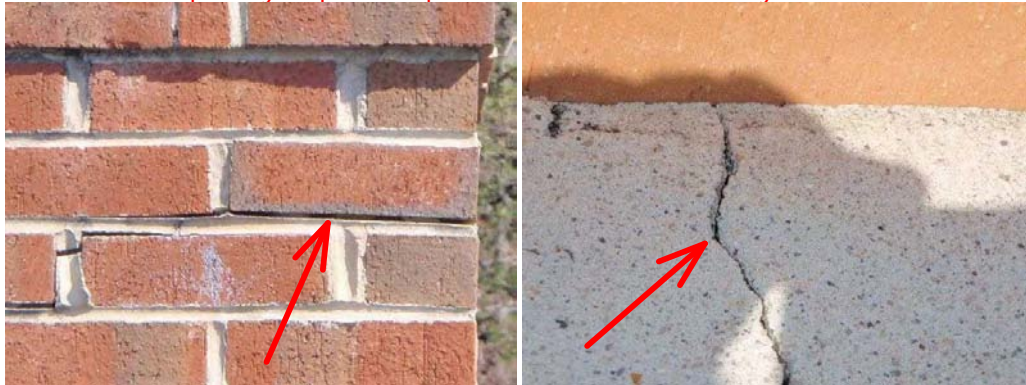
- 10.      Chimney: Masonry:: Cracked mortar joint around chimney near the top. The chimney crown is cracked, which will allow water into the chimney structure resulting in further damage. I recommend repair by a qualified person or licensed masonry contractor.

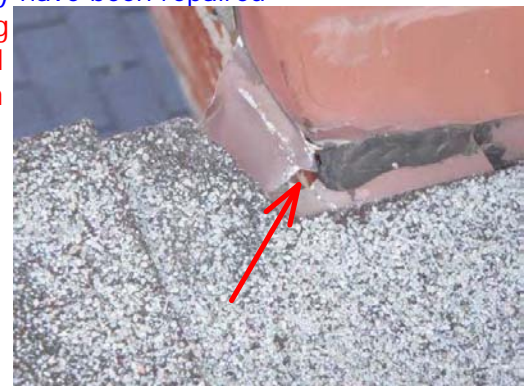
- 11.      Flue/Flue Cap: Clay Tile Flue, Stainless flue cap/screen:: The top section of flue liner appear very clean as does the cap and screen. The flue may have been repaired
- 12.      Chimney Flashing: Metal:: The roof/chimney flashing is starting to come loose and break, sealing material is failing leaving openings to weather. This condition will allow water into the roof structure around the chimney causing more damage. I recommend repairs by a qualified person or licensed roofing contractor.

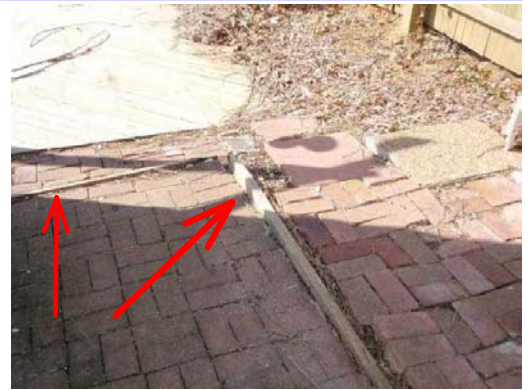
1. Walks: Concrete, Wood, Pavers:: **Wood edging of paver walk and steps sticking up above the uneven paver surface creating a trip hazard. I recommend a qualified person or licensed contractor repair the walk surface to eliminate the trip hazards.**

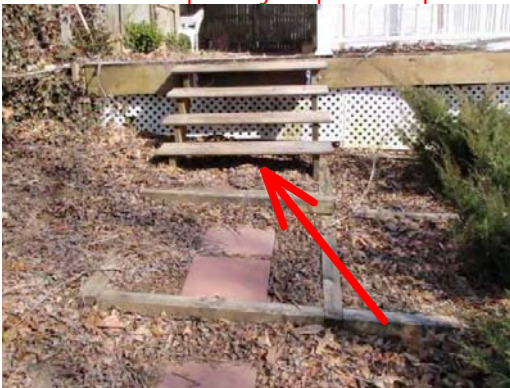
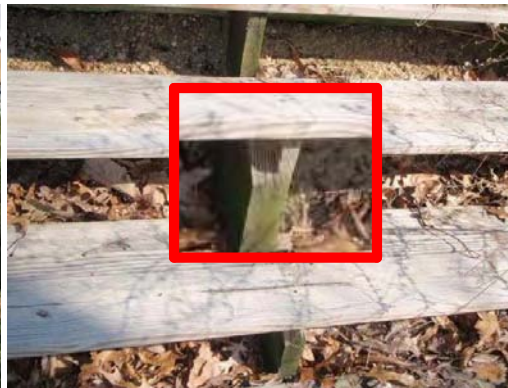
2. Steps: Wood:: **Rear deck steps: I observed uneven step risers and deteriorated stair stringers. I recommend repair by a qualified person or licensed contractor**

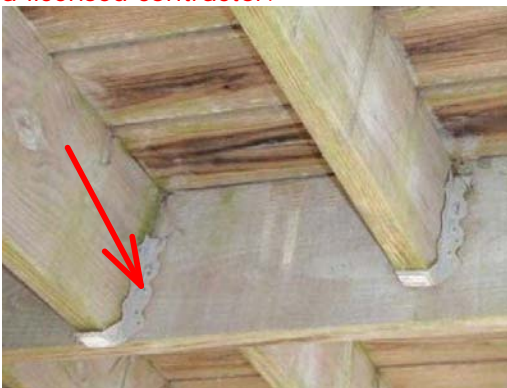
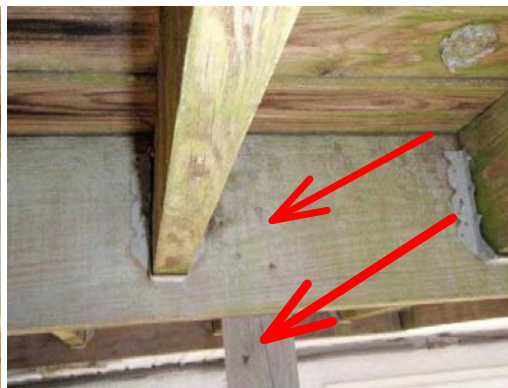
3. Deck: Pressure treated wood 1x6 decking:: **Inadequate nailing of joist hangers. Every round hole requires a proper nail; Improper connection of center beam to support posts. Not Bolted and no support under the beam. Not bolted to the house; Ledger flashing not visible. Weathering of surface. I recommend repair by a licensed contractor.**

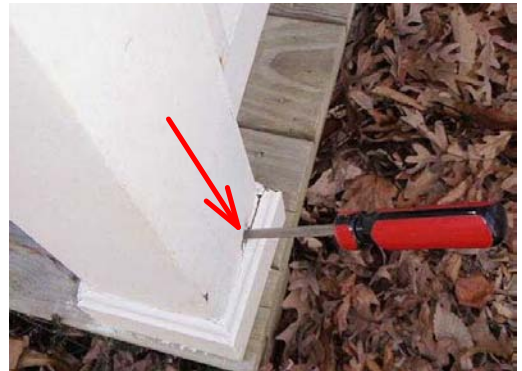
4. Porch: Treated Wood:: Base of right support post shows evidence of damage by WDO. I recommend repair by a qualified person or licensed contractor.

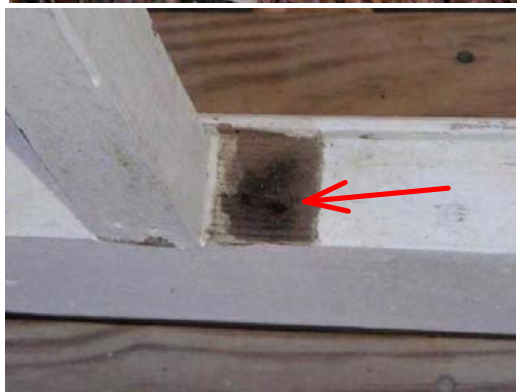
5. Railings: Painted wood rails with painted wood ballusters:: Front porch painted wood railing: Loose and WDO damaged balusters. I recommend repair by a qualified person or licensed contractor.

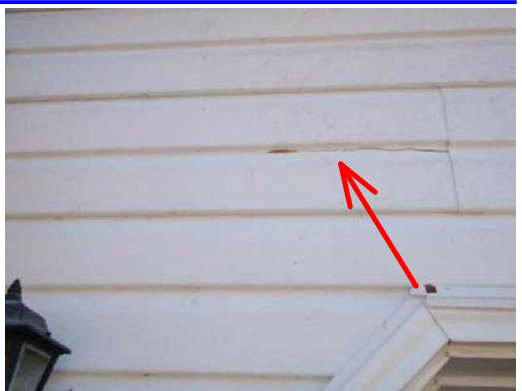
6. . Exterior Surface Condition Requires maintenance, Requires repair:: Caulking required at windows, doors, and/or trim. Caulk provides a moisture, wind, and insect barrier that should be maintained on at least annually. Deteriorated caulking can allow water to enter the structure causing damage to the structure and interior. Insects may use the opening as a convenient road into the house. Observed crack or other damage to siding over the garage door allowing water penetration and possible water related damage to the substructure and interior. Requires repair, or replacement.

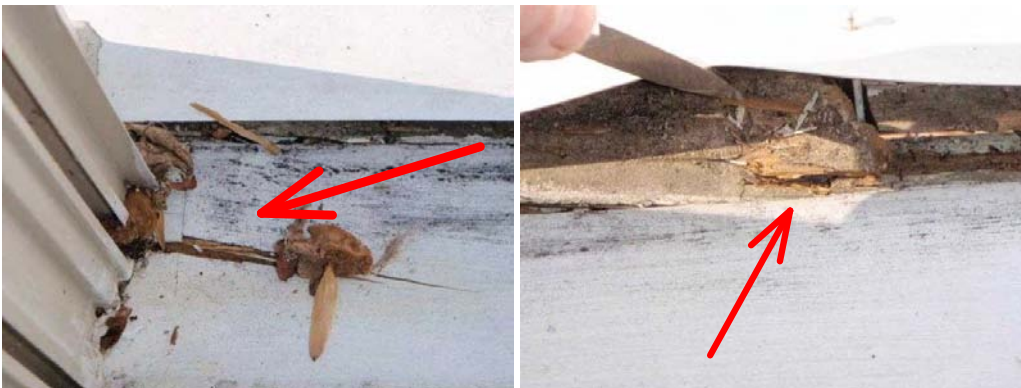
7. Entry Doors: Steel Clad Molded Panels, Stained wood panel door:: Front Door: Door was closed with sliding bolt extended causing the inside metal cladding to deform so that the bolt no longer latches. Requires repair. Bottom weather stripping of front door requires repair or replacement
8. Windows: Wood:: Deteriorated paint in window sills requires maintenance or repair. I observed sills damaged by Wood Destroying Organism, most likely fungal rot. These sills require repair or replacement by a qualified person or licensed contractor

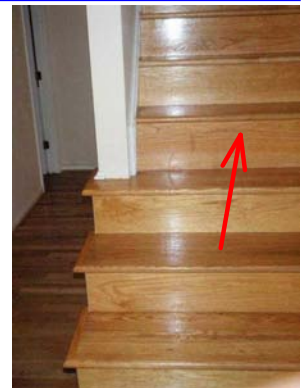
- 10. Stairs: Wood stairs with wood handrails:: Main stairway to second floor: One tread riser is about 1" higher than the average for the stairs presenting a trip and fall hazard. The stairs require repair by a qualified person or licensed contractor.

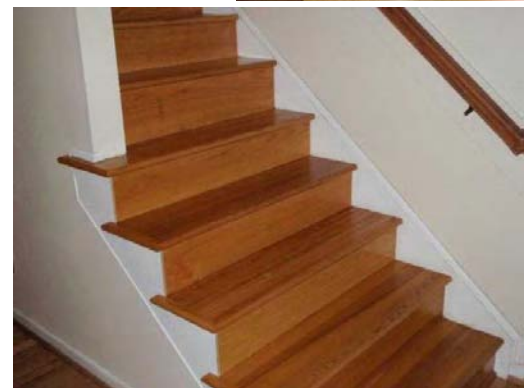
- 11. Railings: Missing railing section:: The handrail for the lower stair section has been removed leaving a five step section without fall protection. This is also a safety hazard that requires repair by a qualified person or licensed contractor.

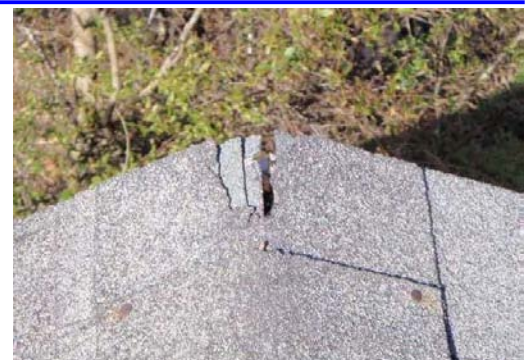
- 12. . Roof Surface Surface Condition: Normal aging and wear, moderate damage:: Ridge cap split at end of main roof exposing roof decking to weather an moisture. Damaged left corner of front porch roof is damaged allowing water to penetrate and damage the decking. At least temporary repairs are required as soon as possible to prevent leaks and damage or reduce existing leaks and additional damage.

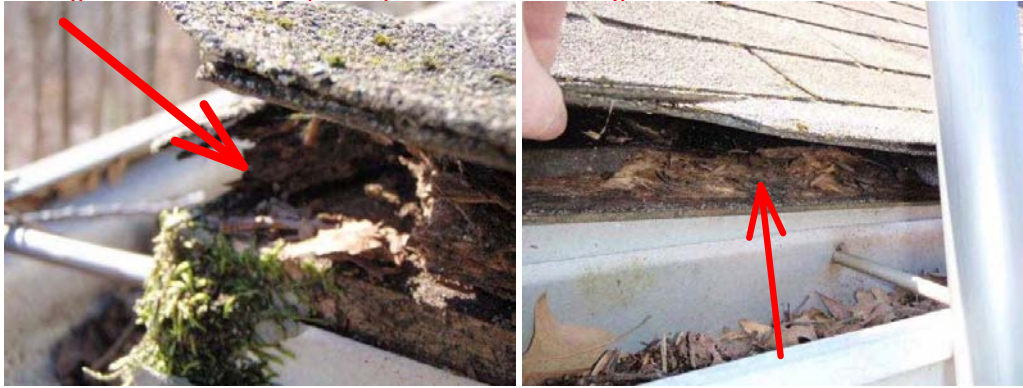
13. . Roof Surface Decking/Nailing: OSB Decking, Galvanized roofing nails:: Water damage at eaves. Overflow from gutters has backed up into the OSB decking at the edge of the roof causing deterioration of the decking. I recommend repair by a licensed roofing contractor.

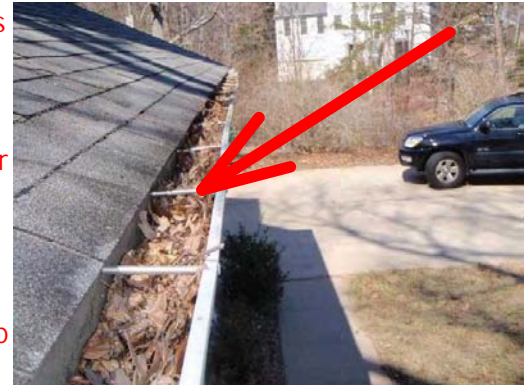
14. . Roof Surface Gutters: Aluminum:: Gutters loose, spikes or straps pulled out or missing. A condition that may severely reduce gutter efficiency and permit moisture entry into the structure or saturate the ground at the foundation. Gutters need cleaning. Clogged gutters can lead to overflow and water penetration into structure or saturate the ground at the foundation. Water can cause structural damage and provide the moisture necessary for mold growth and the existence of termite colonies. I recommend gutter cleaning as part of a regular maintenance program. Uncovered or unscreened gutters should be cleaned at least twice a year to prevent a buildup of debris. Part of the maintenance should also include tightening loose spikes or brackets and sealing any seam leaks.

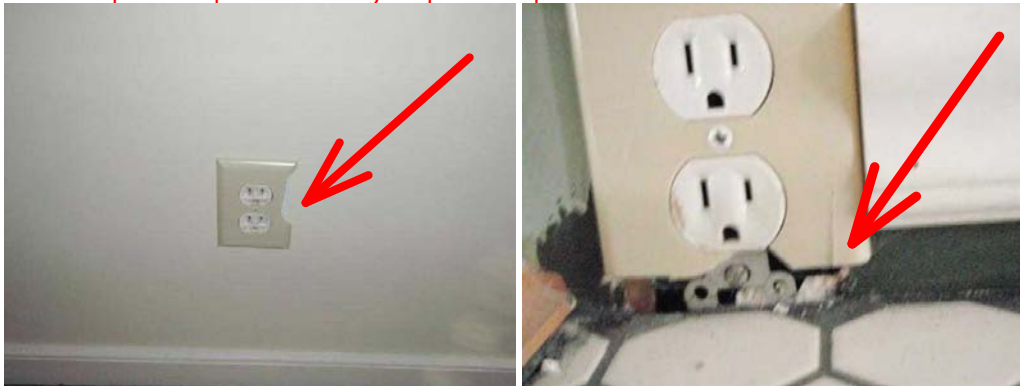
18. Switches/Outlets: safety Issues noted:: Broken receptacle plate in bedroom and behind bar in basement presenting a safety hazard. Replace covers. GFCI receptacle behind basement bar does not trip on "test" or reset. Requires replacement by a qualified person or licensed electrical contractor.

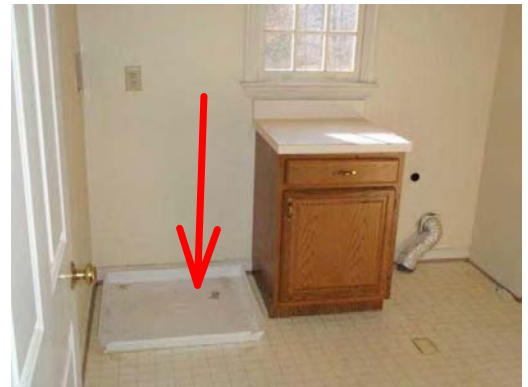
20. 2nd Floor Laundry Room/Area Drip Pan: Plastic Pan:: Broken pan will not hold water. I recommend replacing the pan

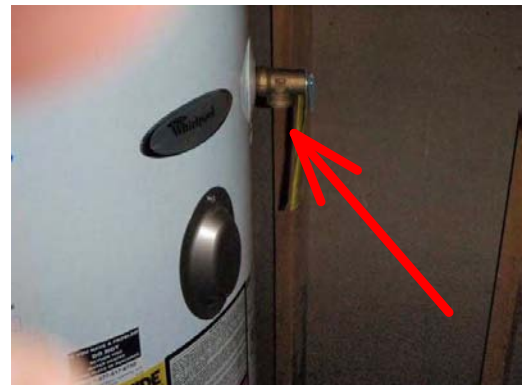
21. Basement Water Heater TPRV Drain Tube: Not installed. This is a safety hazard and requires repair or replacement by a qualified person or licensed plumbing contractor.

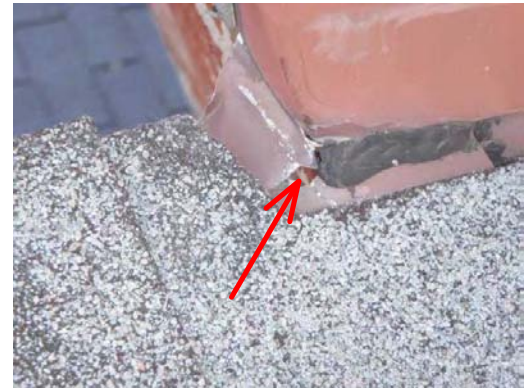
23. Through Roof Chimney Chimney Flashing: Metal:: The roof/chimney flashing is starting to come loose and break, sealing material is failing leaving openings to weather. This condition will allow water into the roof structure around the chimney causing more damage. I recommend repairs by a qualified person or licensed roofing contractor.
