# HOME INSPECTION REPORT

16 Placid Way  
Stafford, VA 22554

Prepared for: Janet MacClient

REPORT NUMBER: 022609-M

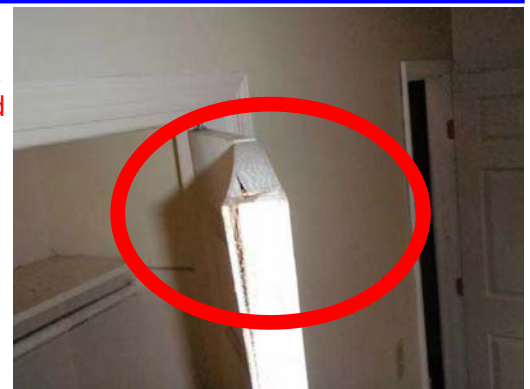
15. Interior Doors: Painted hollow-core molded composite:: Bifold closet door in bedroom requires adjustment and repair. A top track roller is missing and the door is damage where the roller is inserted in the door. The right side master bathroom door needs adjustment apparently due to the settling of the wall and door frame. I recommend repair by a qualified person.

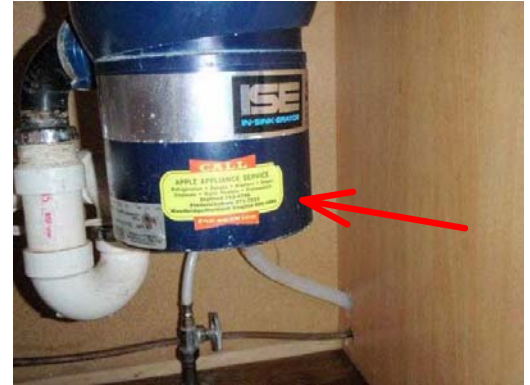
16. Disposal: Not functional at the time of inspection, Motor locked, hums only:: I recommend repair or replacement by a qualified person or licensed plumber contractor

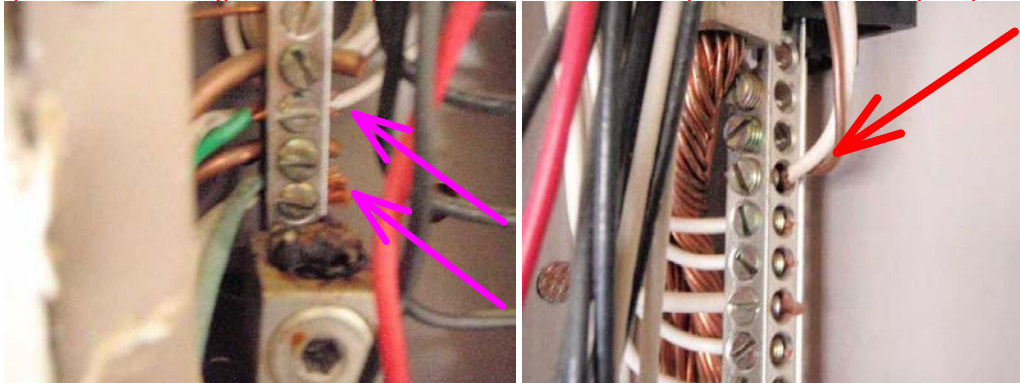
17. Garage Electric Panel Wiring Neutral (white) conductors and a ground (bare copper or green wire) together in one buss bar terminal. Improper wiring technique, Neutral and grounds are combined into one tap, This is a recognized safety and fire hazard that requires correction by a qualified electrical contractor

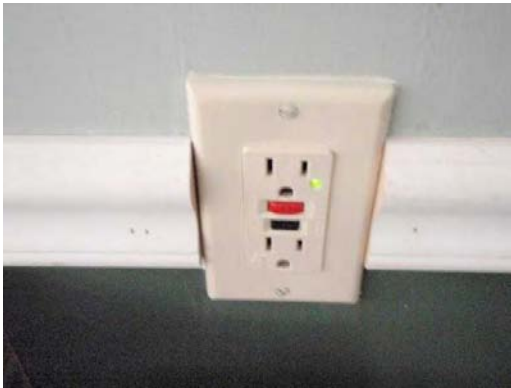
18. Switches/Outlets: safety Issues noted:: Broken receptacle plate in bedroom and behind bar in basement presenting a safety hazard. Replace covers. GFCI receptacle behind basement bar does not trip on "test" or reset. Requires replacement by a qualified person or licensed electrical contractor.

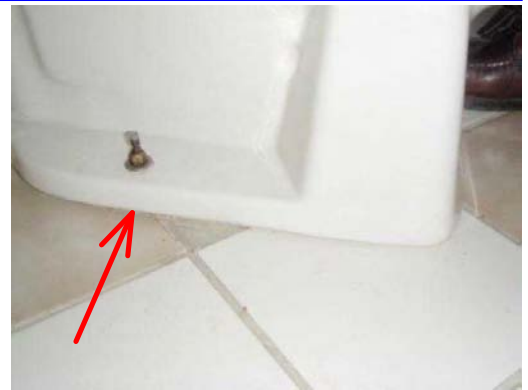
19. Toilets: 1 1/2 Gallon Tank:: Toilet in first floor half-bath is slightly loose at floor mount. I recommend a qualified person or licensed plumbing contractor tighten the toilet and seal around the base of the toilet to prevent water from possible overflows leaking through the floor and into the ceiling in the basement.

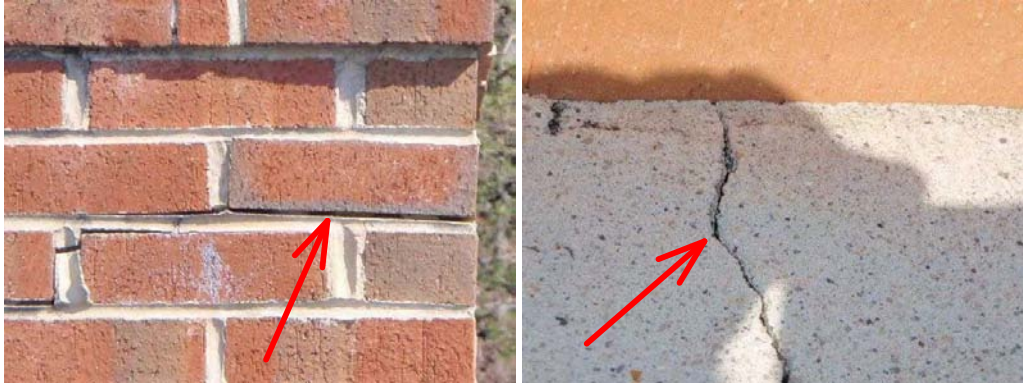
22. Through Roof Chimney Chimney: Masonry:: Cracked mortar joint around chimney near the top. The chimney crown is cracked, which will allow water into the chimney structure resulting in further damage. I recommend repair by a qualified person or licensed masonry contractor.
